# Multiple Fatality Single-Family Dwelling Fire

St. Cloud, Florida

USFA-TR-142/June 2001

Investigated by: John Lee Cook, Jr.

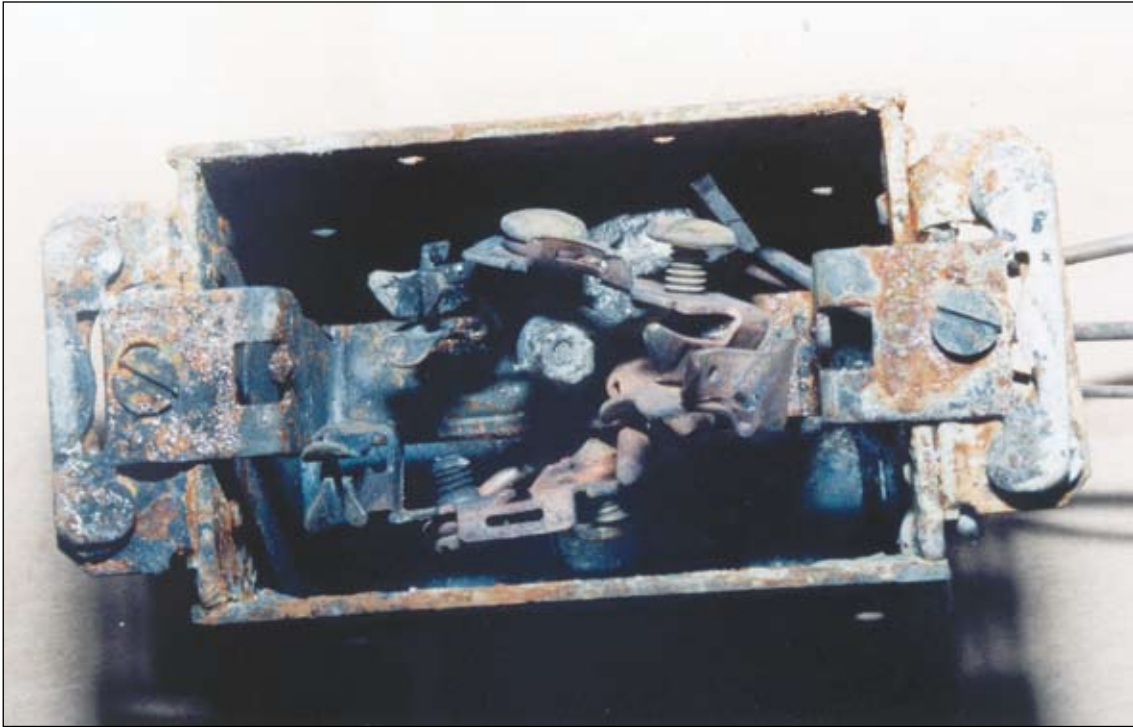
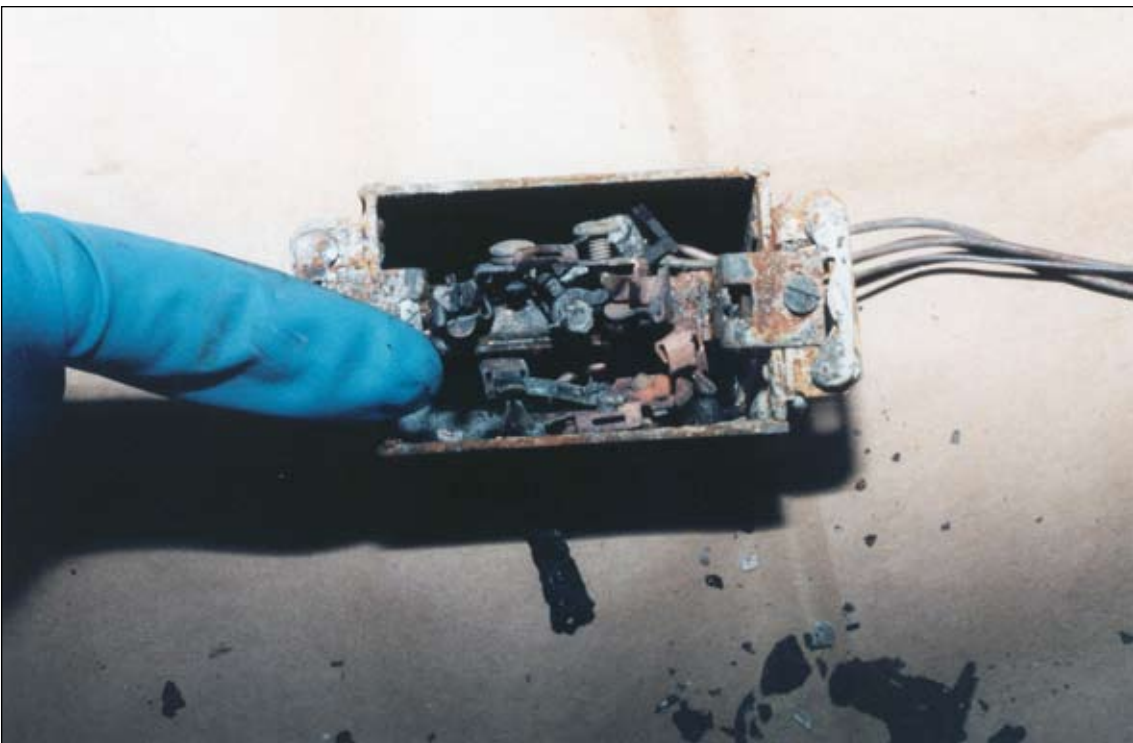
**#37** Close-up of the outlet, with plug still in tack

**#38** See number #37

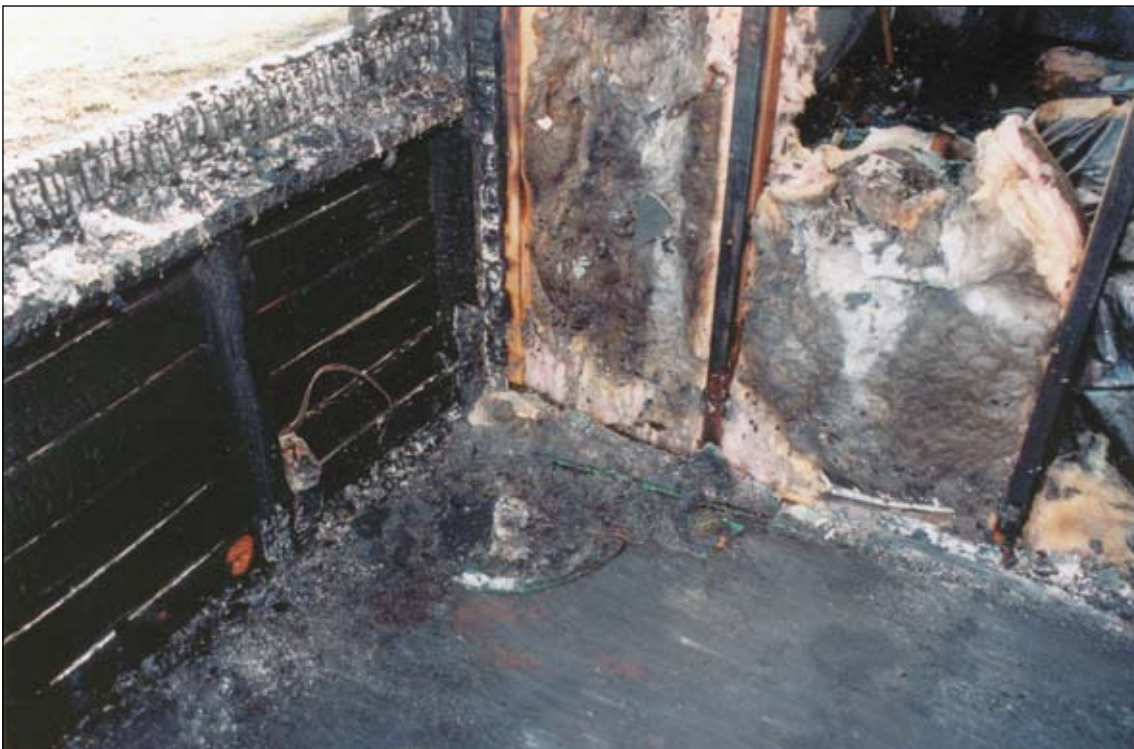
**#40 Point of origin, with outlet box**

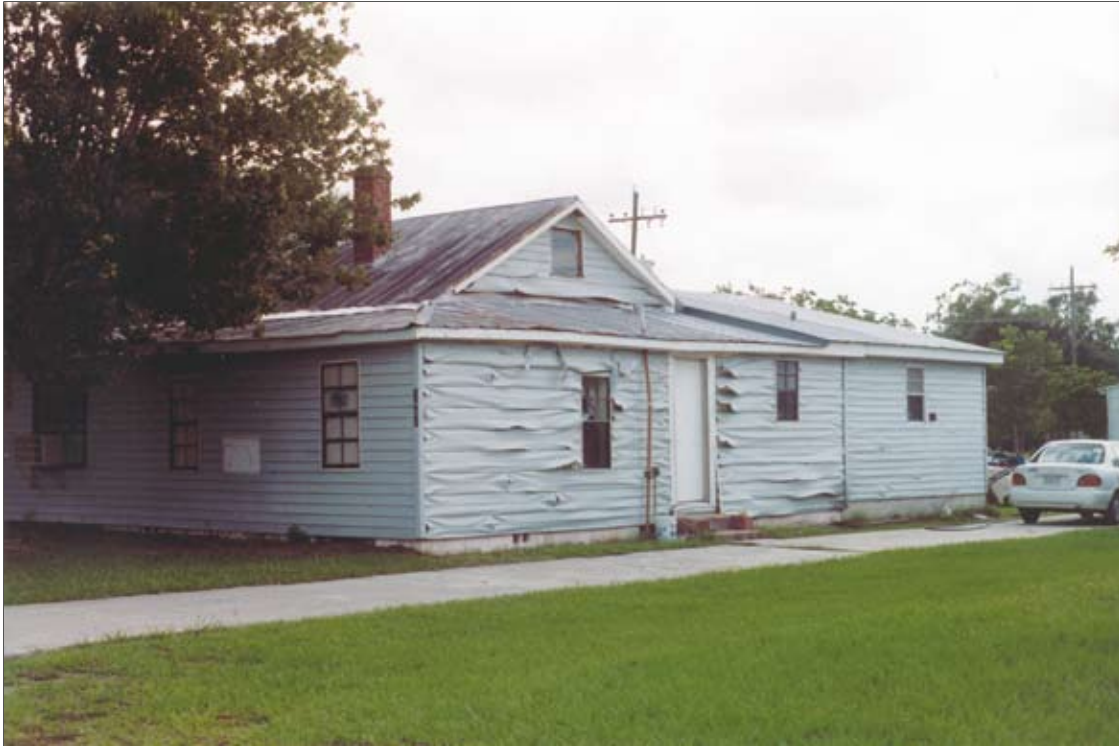
**#44 North exposure: note melted siding**
